# Graphite Fiber Reinforced Thermoplastic Resins

R.C. Novak

United Technologies Research Center  
East Hartford, Ct. 06108

National Aeronautics and Space Administration  
NASA Lewis Research Center  
Contract NAS3-20077

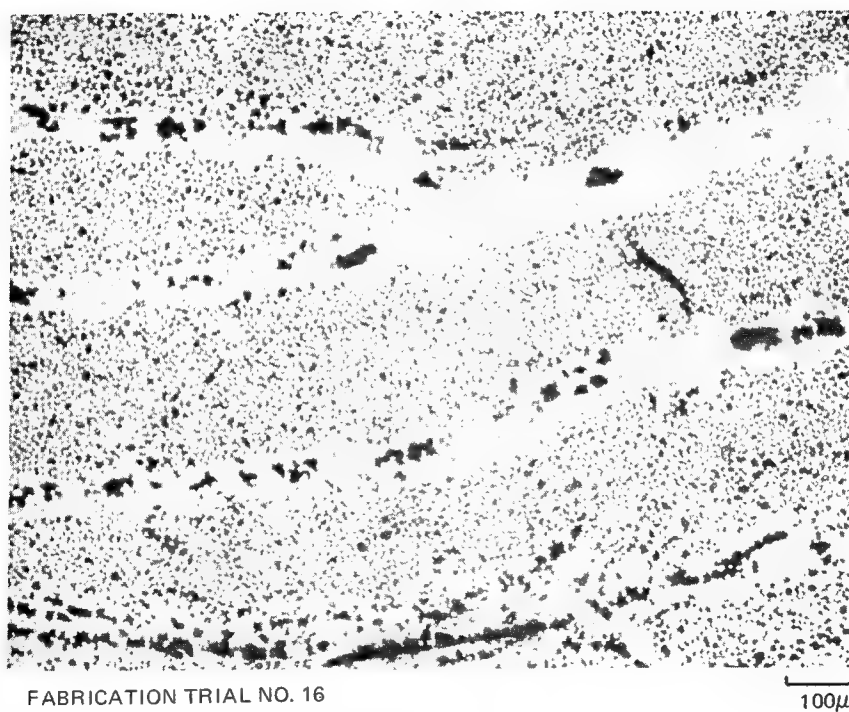
HMS/P-1700 POLYSULFONE FROM 7.5% SOLUTION

One path which was explored to reduce this porosity was to use a more dilute solution thereby lowering the viscosity and improving the chances of the resin fully penetrating the bundle. It was demonstrated that the 7.5% resin solutions did not provide sufficient resin in the composite, and at least an 8.7% solution was necessary. The effect of the lower concentration is shown in Fig. 2. It was also shown that the application of greater pressure, as in numbers 19 and 22 where the latter was hot pressed at a pressure five times higher than the former, did not improve the microstructure of the composite as illustrated in Fig. 3.

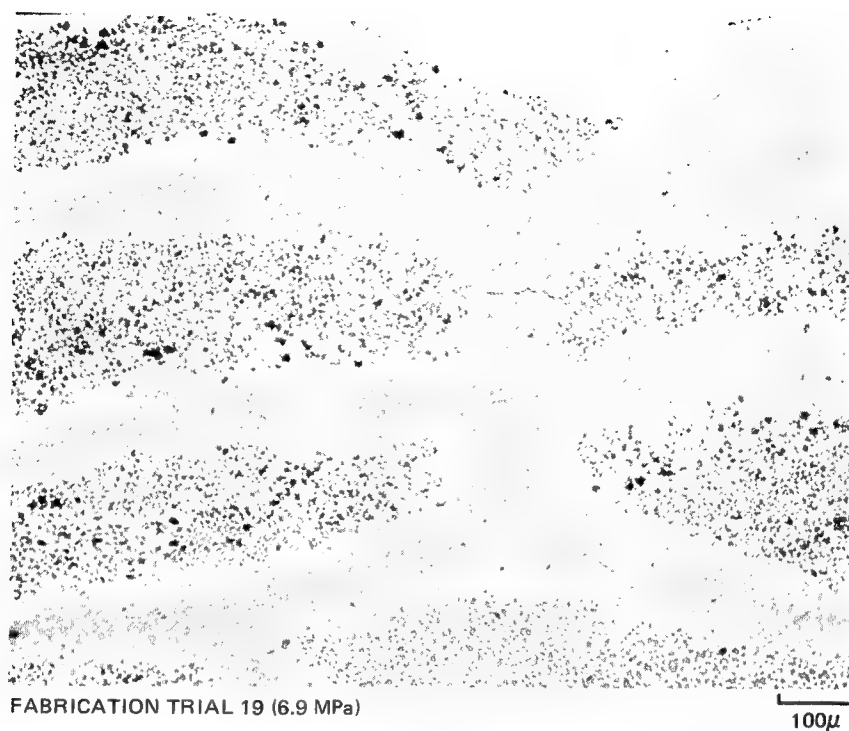
EFFECT OF CONSOLIDATION PRESSURE ON HMS/P-1700 POLYSULFONE

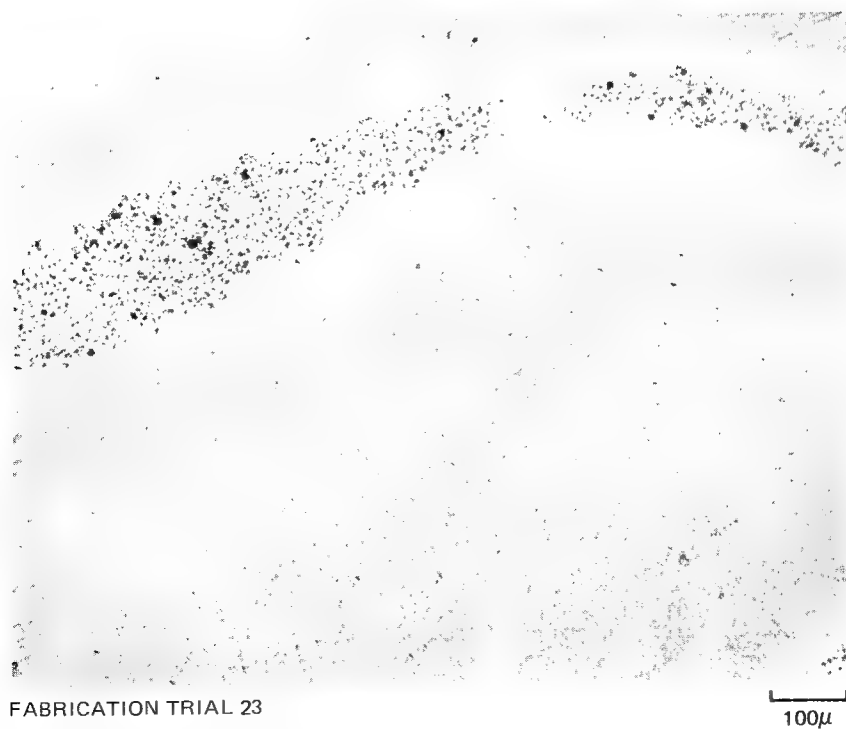
DRYWOUND AND PAINTED HMS/P-1700 POLYSULFONE

Fairly good bundle penetration was obtained with the dry winding and hand painting technique employed in composites 21 and 23 as shown in Fig. 4. This possibly resulted from applying the resin to the tow while it was spread out on the drum and/or the penetration/separation which resulted from the brushing operation. This technique is much more time consuming than the wet winding process and does not lend itself to larger scale operations. Consequently, it was felt to be desirable to achieve better infiltration with the wet winding process.

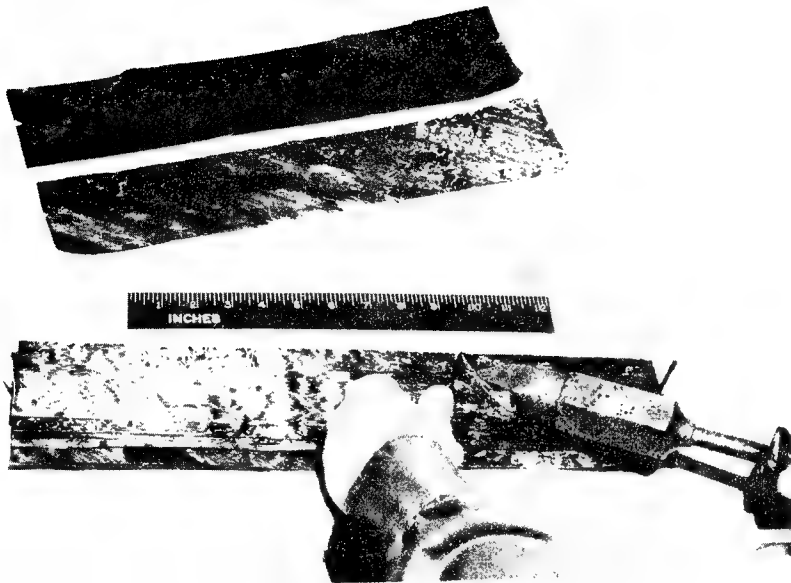
# OPERATION SEQUENCE IN VANE FABRICATION

The sequence of operations in the fabrication of a vane is shown in Fig. 29. The first step shows the package being assembled. Since the prepreg had no tack, the layers were held together by spot heating and locally melting the resin. This technique was found to be more satisfactory than solvent bonding which was much slower and left residual solvent to be removed. The second photograph shows a completed ply package. In order to facilitate handling and to minimize the possibility of misalignment or shifting of the plies, the layup was next subjected to a preforming operation depicted in the third photograph. The plies were inserted between two metal sheets which were bent to a curvature which approximated the camber of the vane. Pressure was applied by clamping, then the assembly was placed in an oven at 285°C for 20 minutes. The fourth picture shows a preformed vane with an aluminum leading strip in position for final molding. The final molding cycle deviated slightly from that used in the previous portions of the program due to limitations of the press used. The intended conditions were 370°C for 60 minutes at a pressure of 13.8 MPa, but the maximum pressure capacity of the press was 8.2 MPa for a part the size of the vane. However, this cycle proved to be completely satisfactory and good flow of the resin was achieved as illustrated in the fifth picture in Fig. 29 which shows both sides of a vane after removal from the mold. After a minor trimming of flash around the edges the finished vane is shown in the final photograph in the figure.
